## **Chief Complaint: Ingested Button Battery**

Rayburn, D., & Welch, J. (2016). Chief Complaint: Ingested Button Battery. *Visual Journal of Emergency Medicine*, 4, 24–26. <http://dx.doi.org/10.1016/j.visj.2016.02.001>

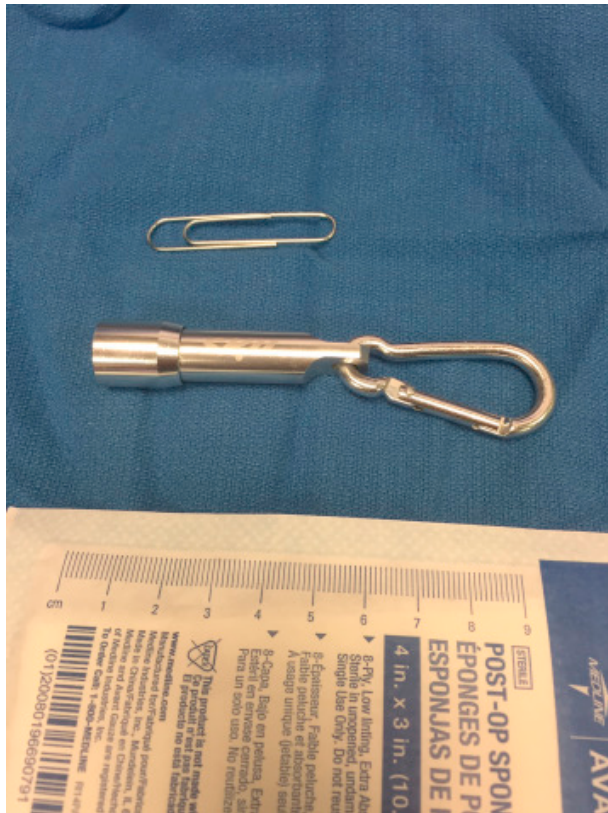
Figure 1. Skil keychain flashlight with paperclip for size comparison. Flashlight contained a standard button battery, which was absent when opened in the ED.

A 3-year-old healthy female was brought to the ED for the potential ingestion of a foreign body (FB), thought to be a button battery (Fig. 1). The child was acting normally and complained of itching in her throat. On examination, her vital signs were stable. She was in no acute distress. Oral pharynx was clear and voice was normal. Respirations were clear with no airway stridor. Abdomen was soft and non-tender.

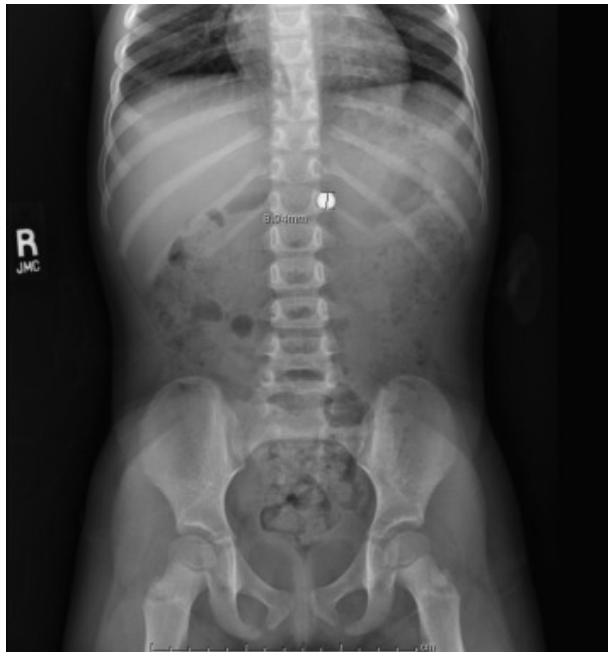
Figure 3. Patient's KUB demonstrating a foreign body, button battery, located in the stomach with no evidence of free air.

Evaluation included a CXR and KUB to determine the location of the FB. CXR was clear without evidence of FB (Fig. 2). The KUB, however, demonstrated a circular FB located in the stomach, pre-pyloric, and just one vertebral body lower than was visible on the CXR (Fig. 3).

The FB in the stomach was presumed to be a button battery; therefore pediatric general surgery was consulted. When the battery is located in the stomach there is the option to attempt endoscopic retrieval or observe with serial radiographs. In this case, it was decided to observe the patient.
